## DAMP & MOULD SURVEY REPORT

| Report Reference | <b>ABM-HHT-036</b> |
| Service | Damp & Mould Inspection |
| Survey Date | 19/08/2026 |

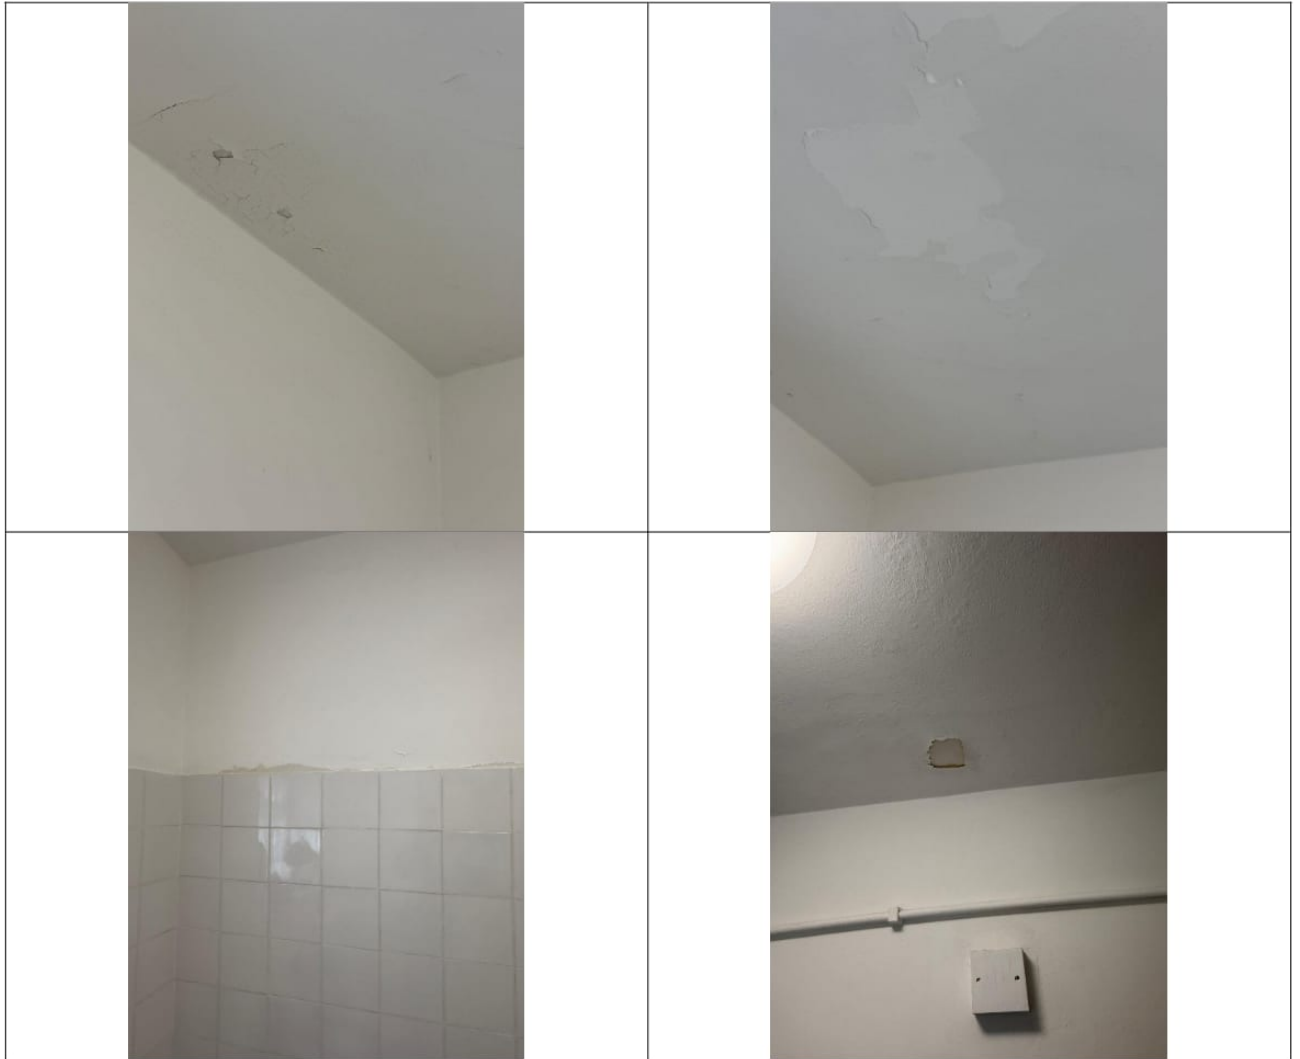
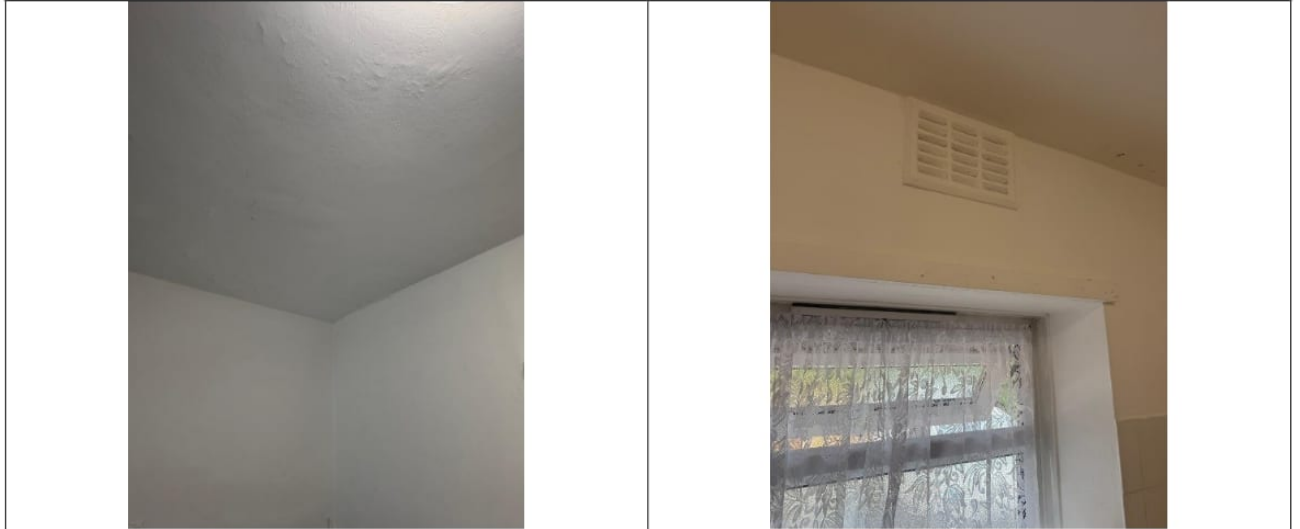
**Internal Photos - Bathroom**

Evidence of visible mould growth was observed to the window reveals, sections of the painted wall and ceiling surfaces. The pattern and distribution of mould growth are consistent with prolonged exposure to elevated moisture levels and condensation within the room.

The inadequate performance of the passive air vent is insufficient to effectively remove moisture-laden air generated during normal bathing activities. This is likely to contribute to persistently elevated relative humidity levels, resulting in surface condensation and the subsequent development of mould growth on cooler surfaces and junctions within the bathroom.

- Treat all mould-contaminated surfaces, including the window reveals and window cills, with an approved fungicidal wash (such as **Bactdet/D05**) in accordance with the manufacturer's instructions. Following treatment and adequate drying, redecorate affected areas using **Bio-Check Anti-Condensation Matt Emulsion** or an equivalent mould-inhibiting coating, strictly in accordance with the manufacturer's specification.
- Replace the existing mechanical extract fan with a humidity-controlled extractor fan capable of achieving the minimum extract ventilation rates specified within **Approved Document F of the Building Regulations**. The installation should be commissioned and airflow tested on completion to confirm compliance with the required performance standards.

- Replace the existing bathroom & kitchen extract fan with a humidity-controlled mechanical extract ventilation unit capable of achieving the minimum extract airflow rates specified within **Approved Document F of the Building Regulations**. The installation should be commissioned and airflow tested upon completion to verify compliance.

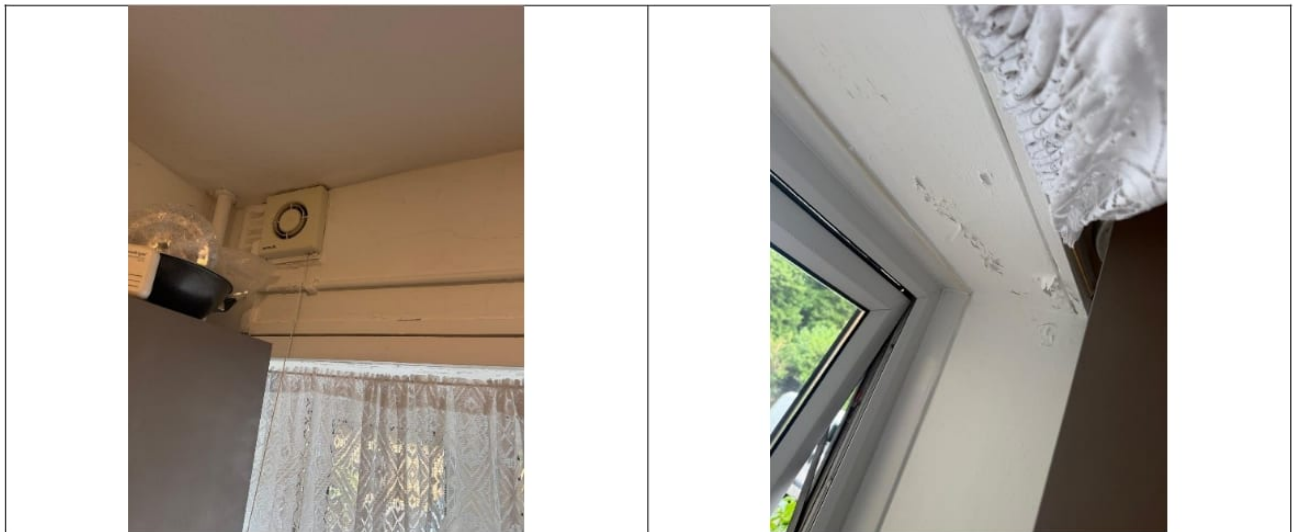
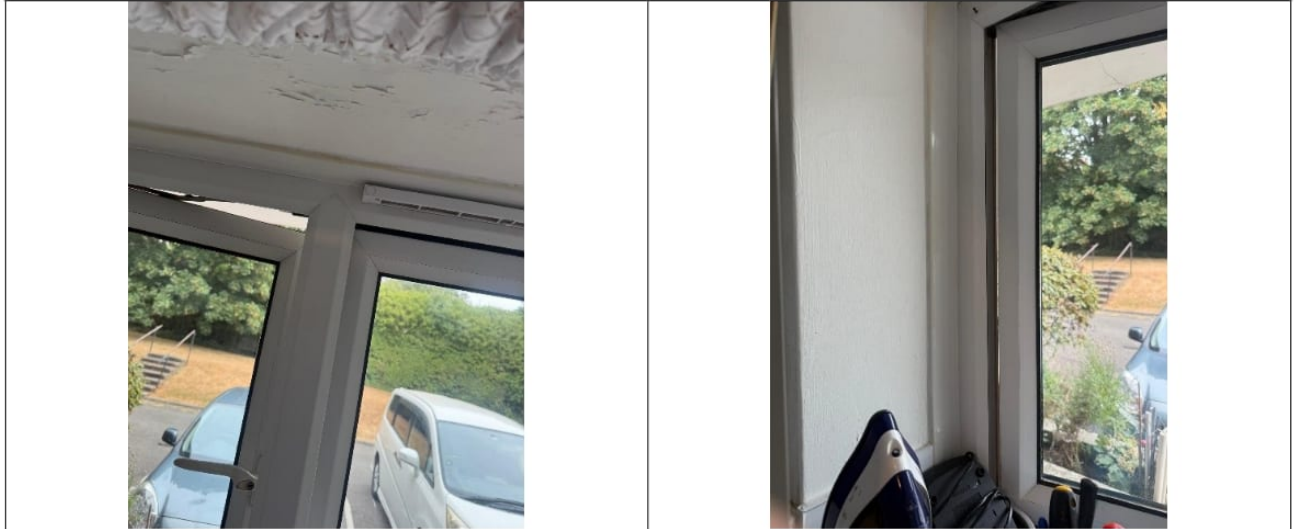
**Kitchen**

Damp and mould were noted to the external wall around the window, with associated blistering and deterioration of the paint finish. The extractor fan was tested and recorded an extraction rate of **2.5 L/s**, which is significantly below the recommended rate of **30 L/s**. This inadequate extraction is likely contributing to elevated moisture levels and should be addressed to improve ventilation and help prevent further damp and mould growth.

At the time of the inspection, the windows were open, and the tenant demonstrated an understanding of the need to purge the air within the property through regular ventilation. However, despite this, the low extraction rate indicates that the mechanical ventilation is not providing adequate airflow and should be improved.

- Treat all mould-contaminated surfaces, including the window reveals and window cills, with an approved fungicidal wash (such as **Bactdet/D05**) in accordance with the manufacturer's instructions. Following treatment and adequate drying, redecorate affected areas using **Bio-Check Anti-Condensation Matt Emulsion** or an equivalent mould-inhibiting coating, strictly in accordance with the manufacturer's specification.
- Replace the existing mechanical extract fan with a humidity-controlled extractor fan capable of achieving the minimum extract ventilation rates specified within **Approved Document F of the Building Regulations**. The installation should be commissioned and airflow tested on completion to confirm compliance with the required performance standards.

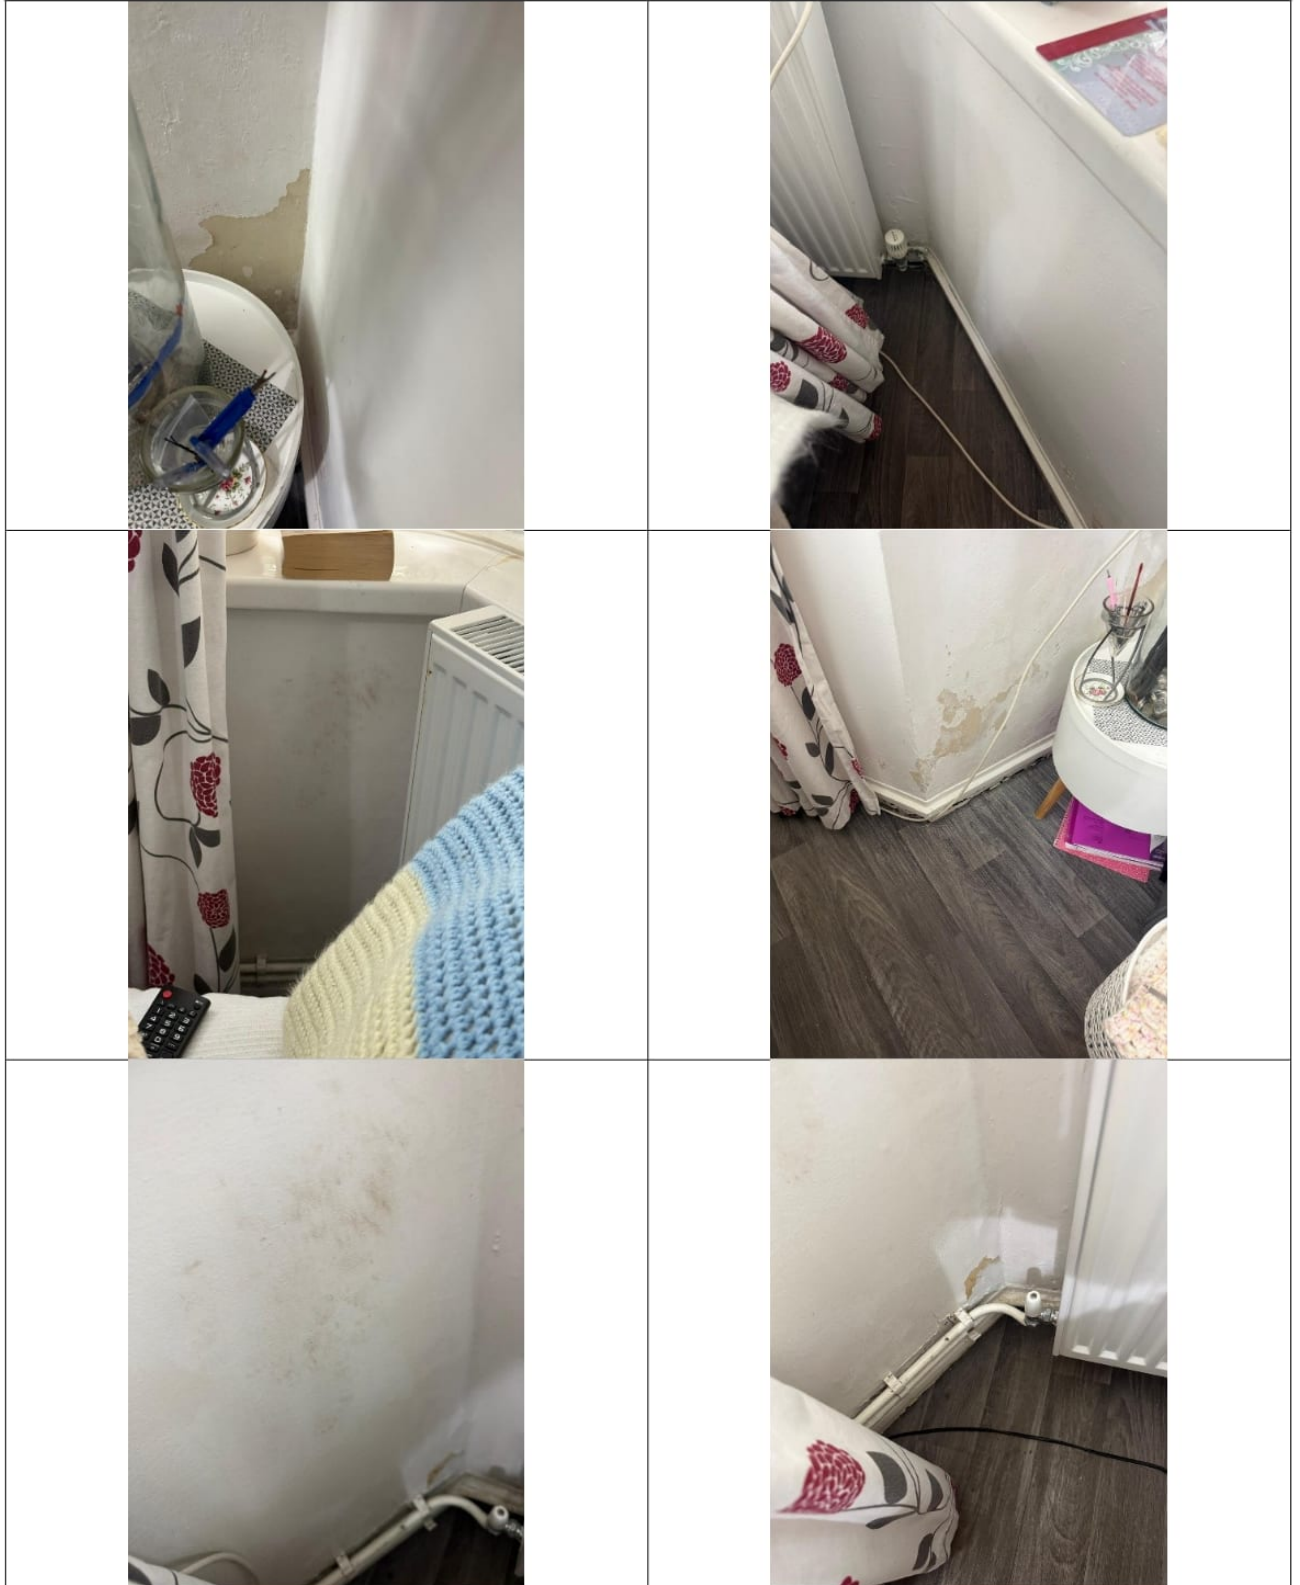
## Lounge

The damp-proof course (DPC) has been bridged externally, allowing moisture to bypass the intended damp barrier. This has resulted in damp penetration and associated damage to the external wall. The bridging should be remedied to prevent further moisture ingress and deterioration.

Visible mould growth was identified to the window reveals and also along the external wall. The distribution of the mould is consistent with localised surface condensation occurring on colder elements of the building fabric. No evidence of moisture ingress associated with the window was observed during the inspection.

- Maintain the existing trickle ventilators in the open position and continue to provide regular background and purge ventilation by opening windows where safe and practicable, particularly following activities that generate moisture within the property.

- Ensure furniture, stored items, and soft furnishings are positioned with an adequate clearance (typically **50–100 mm**) from external walls to promote air circulation and reduce the potential for localised surface condensation.

- Treat all mould-contaminated surfaces, including the window reveals and window cills, with an approved fungicidal wash (such as **Bactdet/D05**) in accordance with the manufacturer's instructions. Following treatment and adequate drying, redecorate affected areas using **Bio-Check Anti-Condensation Matt Emulsion** or an equivalent mould-inhibiting coating, strictly in accordance with the manufacturer's specification.

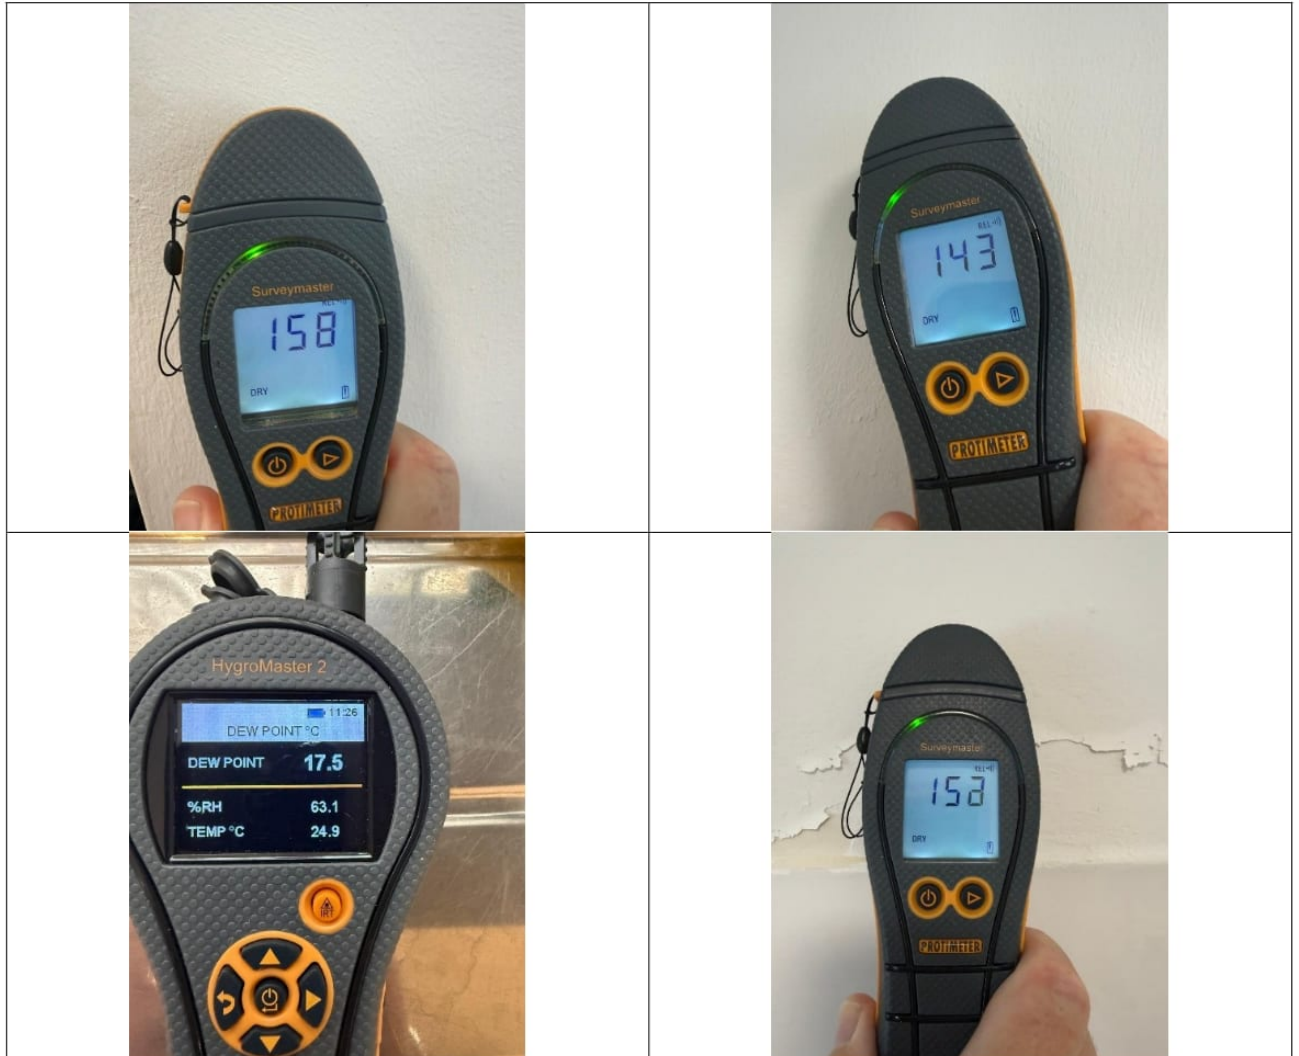
**Meter Readings in Bathroom**

| <b>Location</b> | <b>Dew Point</b> | <b>Relative Humidity%</b> | <b>Temperature degrees (C)</b> | <b>Surface</b> | <b>Moisture readings%</b> |
|---|---|---|---|---|---|
| Bathroom | 17.1°C | 64.2% | 24.2°C | 27.6°C | 158% |

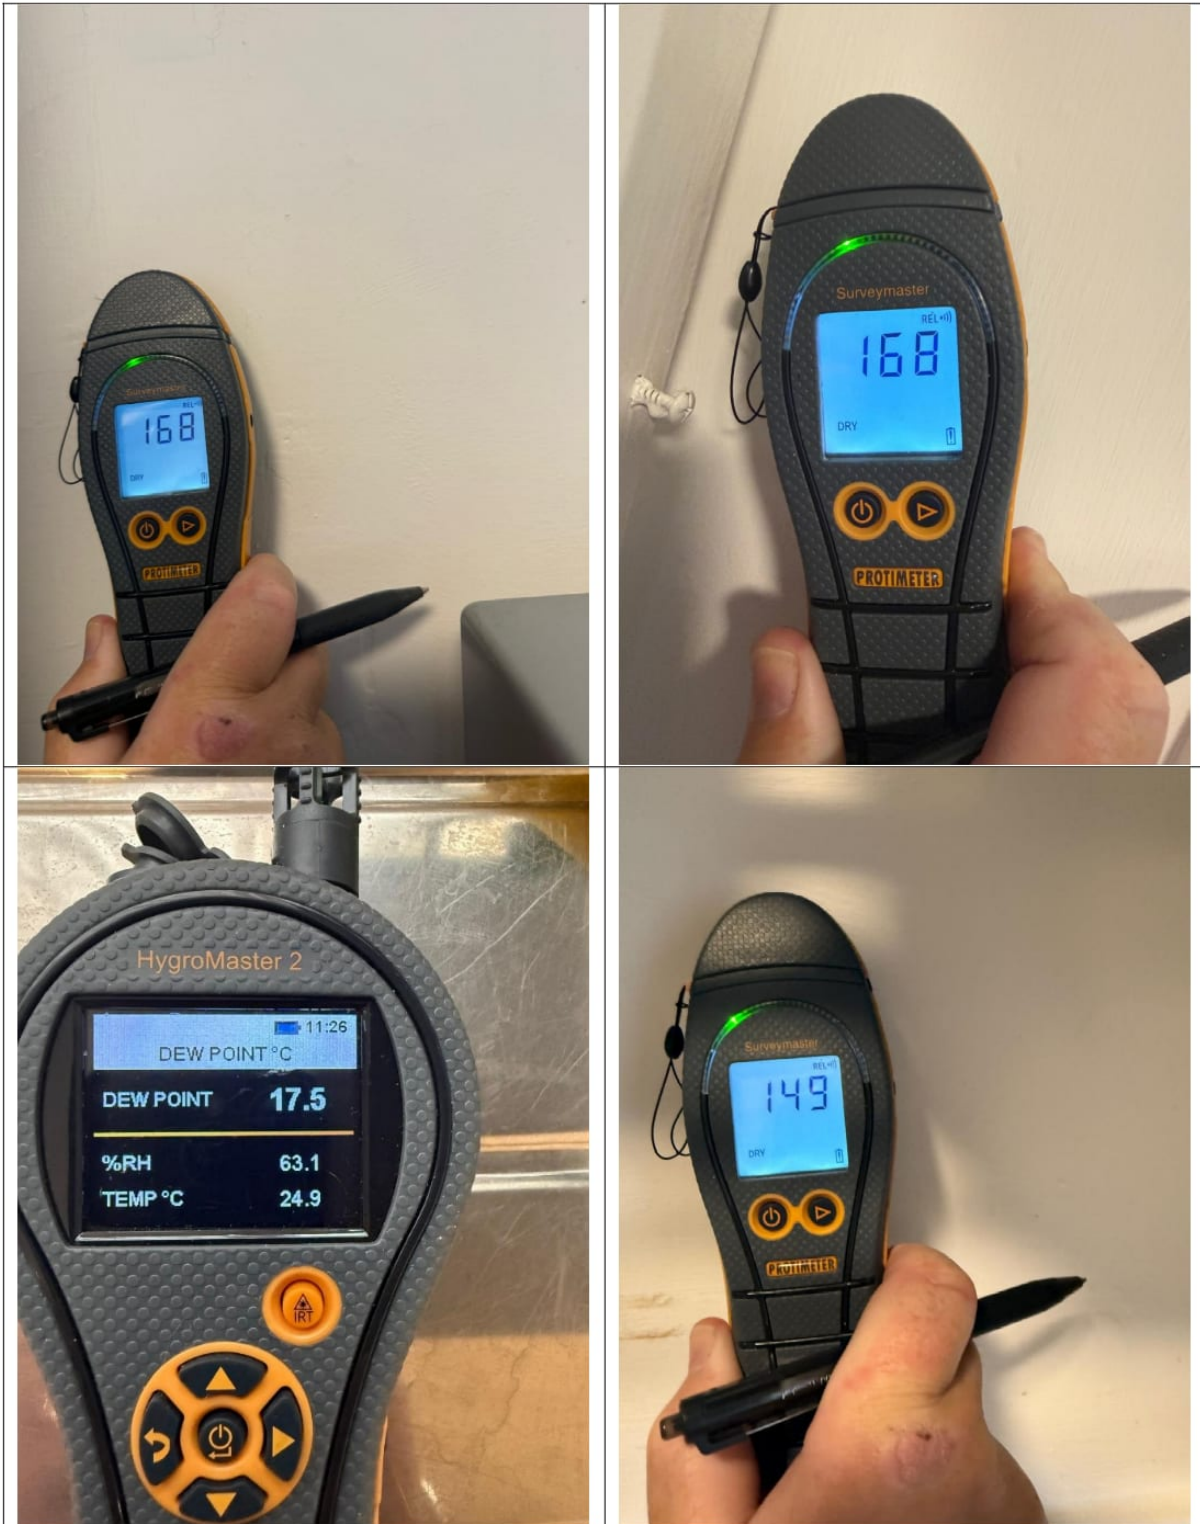
**Meter Readings Kitchen**

| <b>Location</b> | <b>Dew Point</b> | <b>Relative Humidity%</b> | <b>Temperature degrees (C)</b> | <b>Surface</b> | <b>Moisture readings%</b> |
|---|---|---|---|---|---|
| Kitchen | 17.5°C | 63.2% | 24.9°C | 27.1°C | 168% |

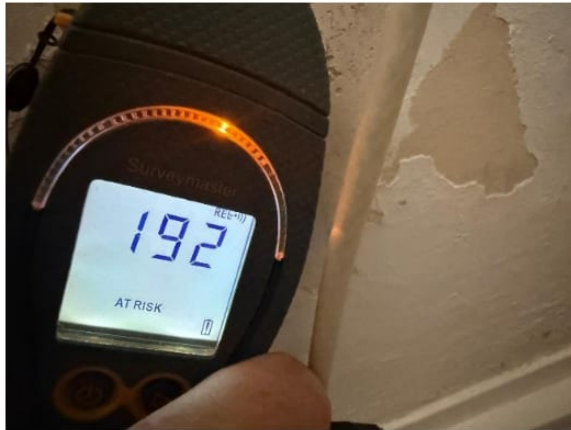
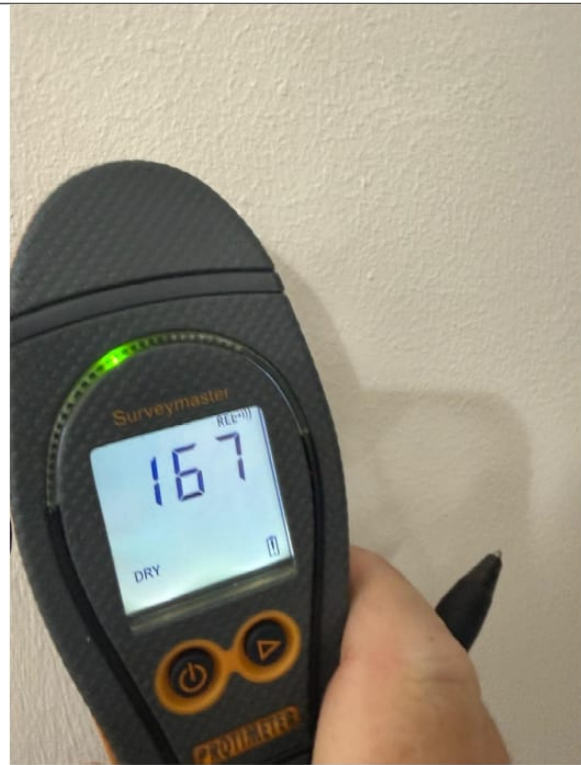
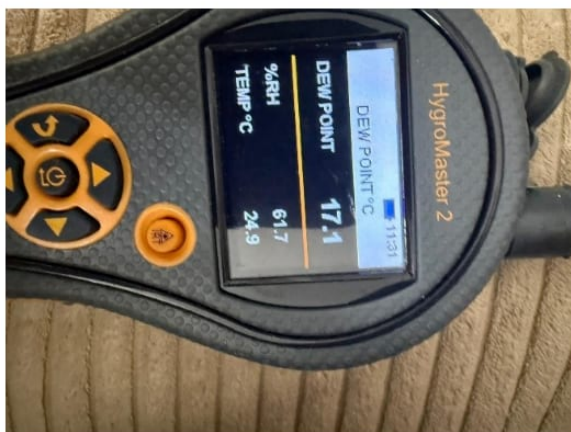
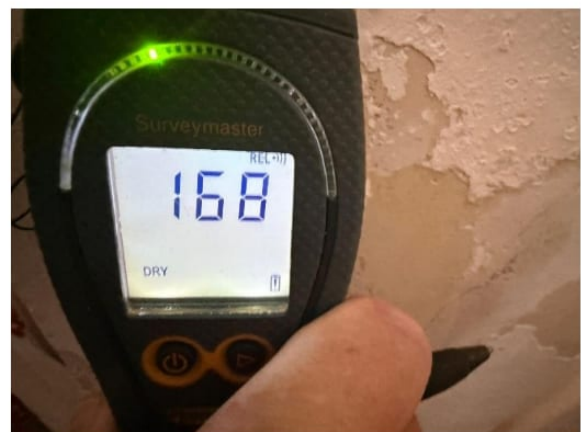
**Meter Readings Lounge**

| <b>Location</b> | <b>Dew Point</b> | <b>Relative Humidity%</b> | <b>Temperature degrees (C)</b> | <b>Surface</b> | <b>Moisture readings%</b> |
|---|---|---|---|---|---|
| Lounge | 17.1°C | 61.7% | 24.9°C | 27.4°C | 192% |
